## **Battery Installations Common Defects**

### **Industry Webinar 3rd December 2024**

Solar Technical Manager TechSafe Australia

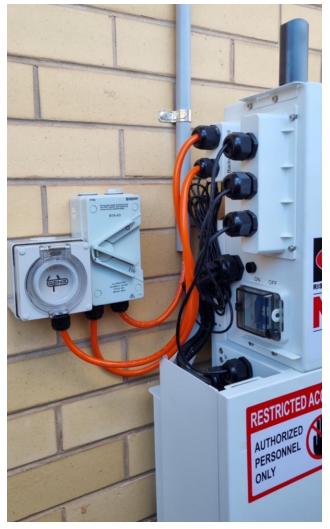
- Where multiple supplies are provided, each supply shall be controlled by a main switch....
- There shall be a main switch for the stand-alone port of multiple mode IES.
- In this example, a socket outlet has been wired to operate off the backup port of multi-mode inverter/battery system. Unfortunately, the backup circuit has not been provided with a main switch.

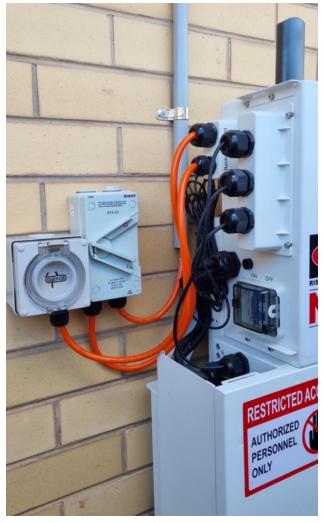
- Additional protection by RCDs with a maximum rated residual current of 30 mA shall be provided for final subcircuits with a rating not exceeding 32 A supplying socket outlets.
- In this example a socket outlet has been wired as a final subcircuit and operated off the backup port of multi-mode inverter/battery system. Unfortunately, no additional RCD protection has been installed for the socket outlet.

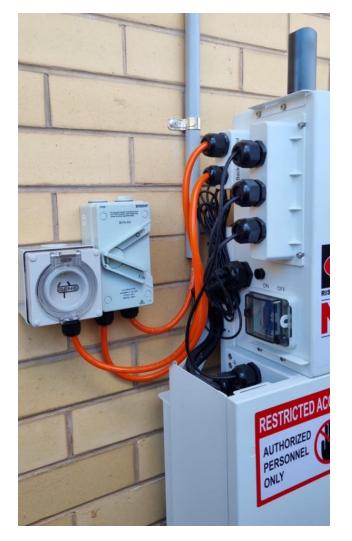
- Where an electrical installation, or part thereof, is provided with an alternative supply in accordance with Clause 7.3, an isolating switch shall be provided at the source of supply or at a switchboard, in accordance with Clause 7.3.
- In this example an alternative supply has been utilised from the backup port of the multimode inverter and no isolation device has been supplied to isolate that circuit from the battery system.

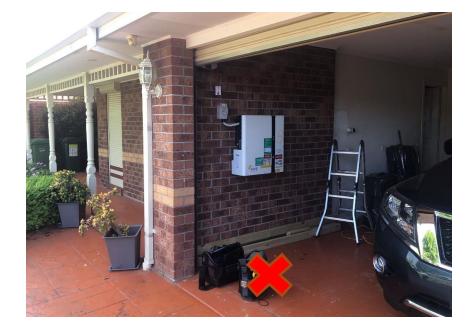
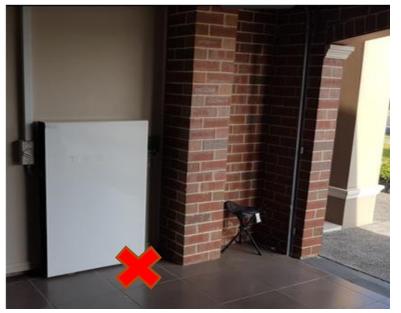
Where the battery system is located in the front corner of a standard 6m long garage and is protected by a solid front pillar or wall, it is reasonable to expect vehicle impact could not occur, therefore a bollard may not be required in this location (Please see below Fig .1). If the battery system is set further back, then the area afforded protection by garage pillar then additional protection may be required.

Additionally, if the garage is longer than 6m and could allow a vehicle to proceed past the battery system, then additional mechanical protection may also be required on the trailing edge of battery system.

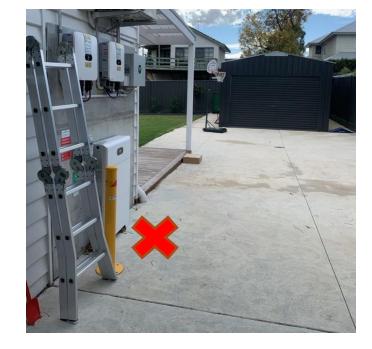
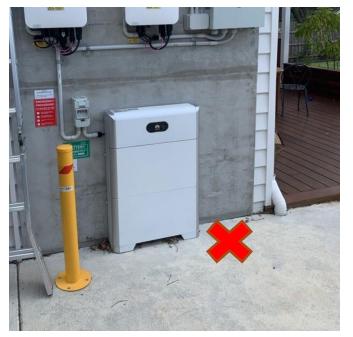
In this example the installed battery system was determined to have sufficient mechanical protection for vehicle strike from the leading edge. However, after further inspection it was determined that a vehicle could travel past the battery system and potentially strike the battery system from the trailing edge. As such an additional bollard would need to be installed near the trailing edge of the battery system in this example to ensure adequate mechanical protection from vehicle strike.

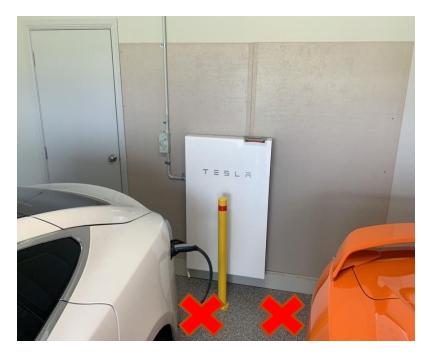
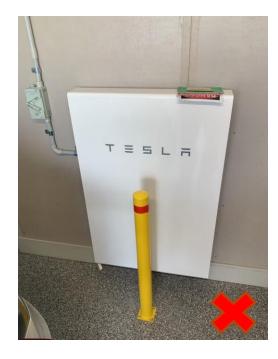
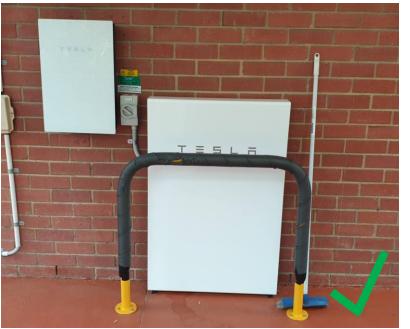
In this example a bollard has been installed in front of the battery system to protect against vehicle strike. The centre placed bollard is inadequate to protect against potential vehicle strikes on the left and right hand sides of the battery. Suggested compliant protection for this example may include the installation of 2 additional bollards (either side of the battery) or a U-shaped bollard system installed around the front of the battery system.

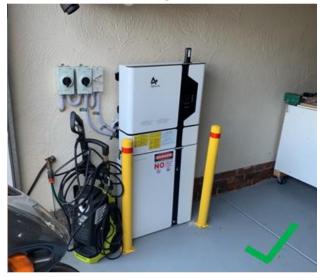
Example 2

- Example 2: There is no garage pillar protection, so the installer has provided mechanical protection on both the leading and trailing edges of battery system to mechanically protect against potential vehicle strikes.

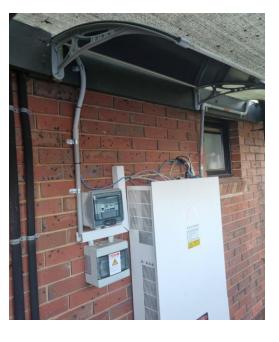
In the below example a battery system has been installed with an ingress protection rating of IP30. This means there is zero water ingress protection provided by the battery enclosure. The installer has made an attempt at protecting the battery system by installing a small veranda/overhang above the battery. As the electrical equipment has no water ingress protection rating, in this example the entire piece of equipment would need to located within 30 degrees of an adequately waterproof veranda or overhang. (as per AS/NZS 3000:2018 clause 4.1.3)

sonnen GmbH Am Riedbach 1 DE-87499 Wildpoldsried sonnenBatterie hybrid 9.53 smai number:		PLUS DO USER
Annumber / revision 4 anguest tamperature: degree of protection protection class: As setings - system output inverse topology batt; function means connection 1 toomay interaction 1 toomay interaction 1	-5 45 C IP30 mal-isolated ph + N + pc	rgy - system [kWh]   ver - battery [kW]) = /12.5 (11.25   3.3) = /15 (13.5   3.3)
Romer Lactor Power:	50 Hz 4.6 kW 9 motor 1 mpt rack 20 A maximum pount 40 maximum	er. 2
and barn	nt 10 kA maximum power maximum current short circuit current	75 60 V 6.5 kW 13 A 15 A

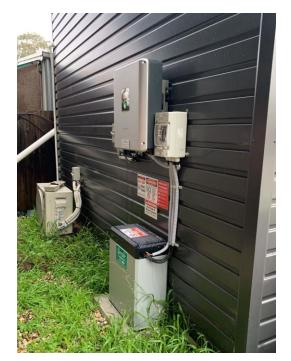
Most manufacturers will stipulate additional installation requirements above the minimum outlaid in Australian installation standards. Please ensure you read these before beginning any works and apply as required under AS/NZS 3000:2018 clause 4.1.2 (e). Please see below for an example of a manufacturers additional requirements potential not being met.

The RESU battery pack is rated at IP55 and thus can be installed outdoors as well as indoors. However, if installed outdoors, do not allow the battery pack to be exposed to direct sunlight and moisture.

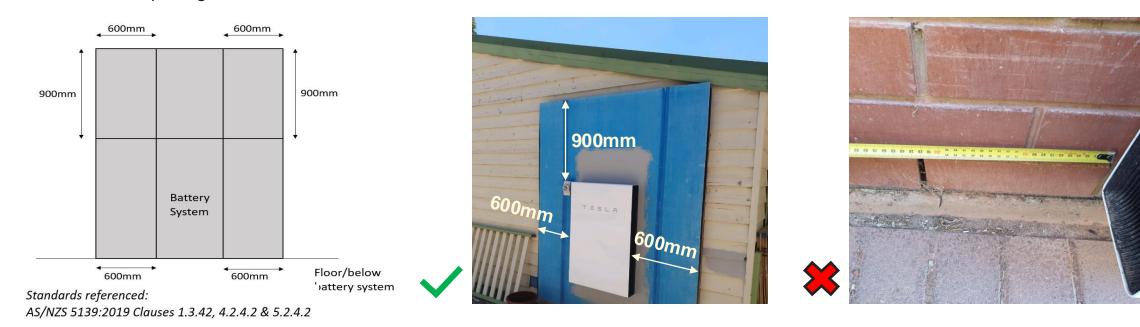
AS/NZS 5139:2019 clause 4.2.4.2 & 5.2.4.2 states that if a battery system is mounted on or placed against or near a surface of a wall or structure that has a habitable room on the other side, the wall or structure shall be a suitably non-combustible barrier. If the mounting or nearby surface itself is not made of a suitably non-combustible material, a non-combustible barrier shall be placed between the battery system and the surface of the wall or structure. The dimensions for the required non-combustible barrier are listed below (figure 1). If the battery system is within 900mm of the ceiling surface, then the ceiling must also be protected with a non-combustible barrier that extends 600mm past the outer extremities of the battery system.

Additionally, the standard states any penetration through a non-combustible barrier to a habitable room within the defined zones, with an internal free space greater than 5mm diameter, shall be sealed with a fire-retardant material.

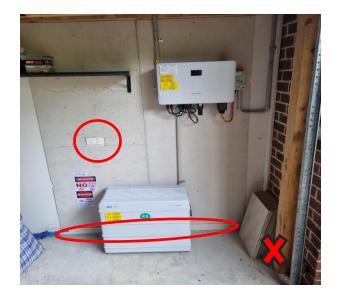
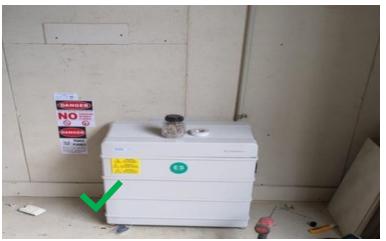
- In the below example a battery has been installed backing onto a habitable room.
- An attempted has been made to provide a non-combustible barrier of compressed cement sheeting to protect against the potential spread of fire.
- In the supplied example the barrier does not extend the required 600mm to the left-hand side of the battery system.
- There is also a combustible skirting that is within the defined zone.
- Additionally, a gap with internal free space greater than 5mm has been created in the non-combustible barrier in order to install a socket outlet that is not sufficiently rated as non-combustible.

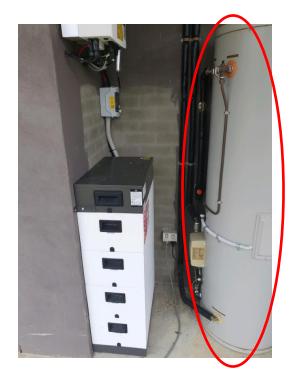
In the below examples a battery system has been installed within 600mm of appliances not associated with the battery systems. As such the battery systems would be in a restricted location and uncompliant as per AS/NZS 5139:2019 clauses 4.2.2.2 (d) and 5.2.2.2 (d).

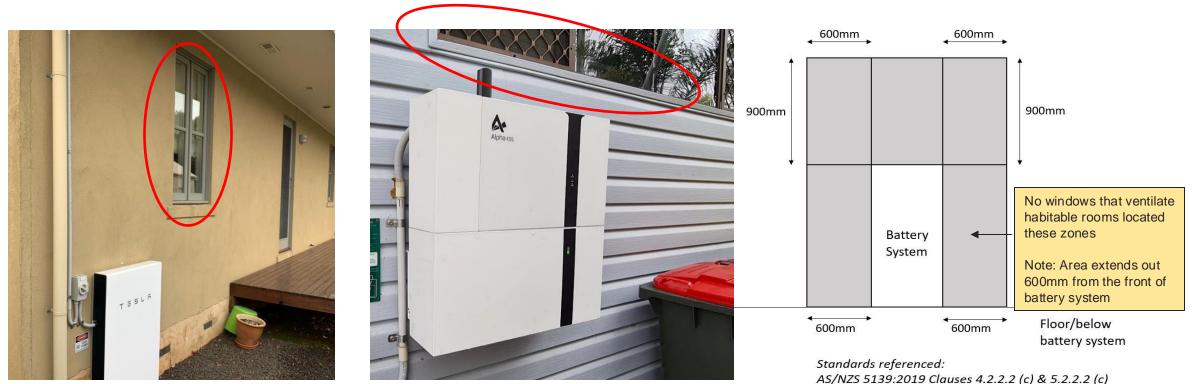
In the below 2 examples a battery system has been installed in a restricted location. Battery systems must not be installed Within 600mm of the vertical side, and 900mm below a window or building ventilation system that ventilates a habitable room. As such the battery locations would be non-compliant with AS/NZS 5139:2019 Clause 4.2.2.2 (c) and 5.2.2.2 (c).

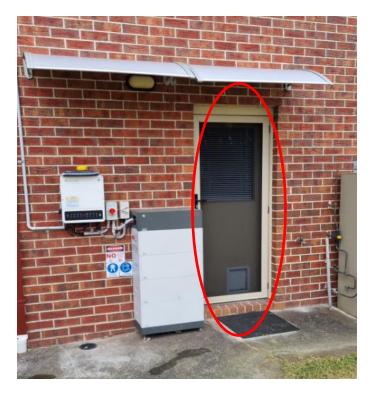
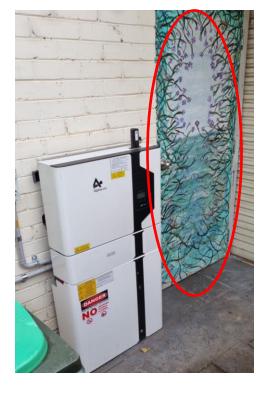
In the below 2 examples a battery system has been installed in a restricted location. Battery systems must not be installed within 600mm of an exit/entry doorway to a room or building. As such the installation locations would be uncompliant as per AS/NZS 5139:2019 Clause 4.2.2.2 (b) and 5.2.2.2 (b)

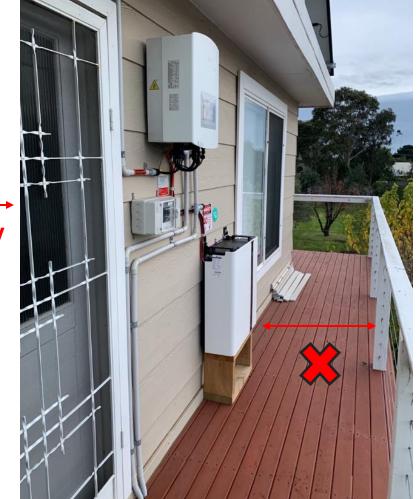
In the below example a battery system has been installed on a second story balcony with one entry/exit. In this specific scenario as there is only 1 entry/exit to the balcony the battery system cannot be placed in a location that would prohibit occupants from safely reaching the entry/exit if they were located past the battery system. The battery systems must not be installed in an evacuation or escape route without sufficient space to egress past the system (free space greater than 1m from the front of the battery system).

Single exit  $\rightarrow$  from balcony

Less than 1m clearance

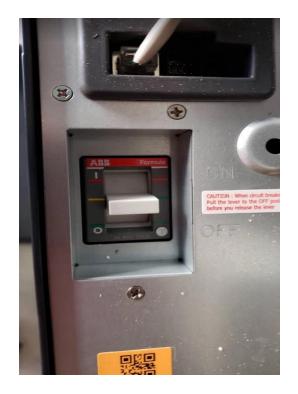
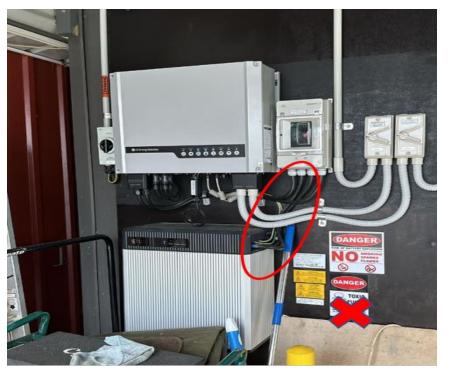
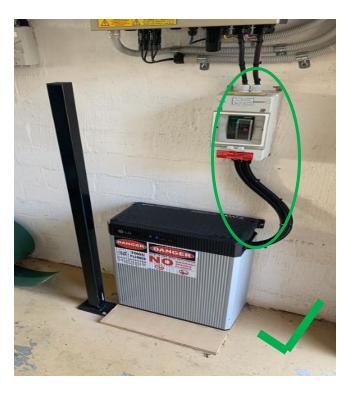
In the below examples, the battery manufacturer does not allow their internal overcurrent protection to protect outgoing conductors. As such the installer is required to install external overcurrent protection and enclose the cables between the battery system and the external overcurrent protection device in at least medium duty conduit.

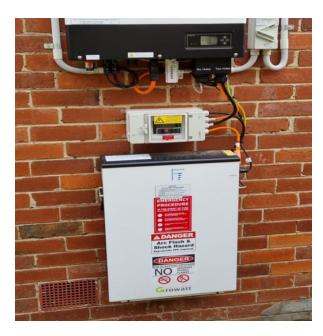
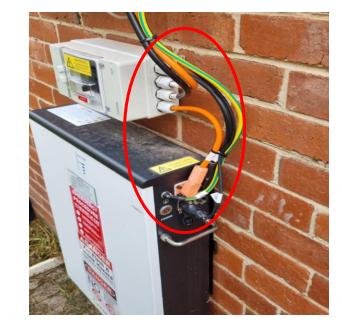
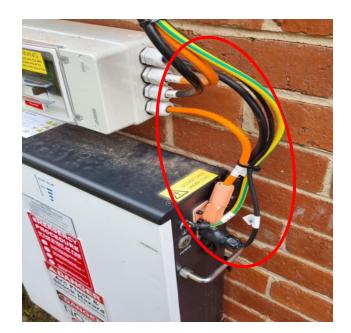
In the below example, the battery manufacturer has stated there is internal overcurrent protection in the battery system, however the internal fuse protection is rated higher than the current carrying capacity of the outgoing cables. As such the installer is required to install additional overcurrent protection and enclose the cables between the battery system and the external overcurrent protection device in at least medium duty conduit. As can be seen external overcurrent protection has been installed however the cables between it and the battery system have not been enclosed in MD conduit as required.

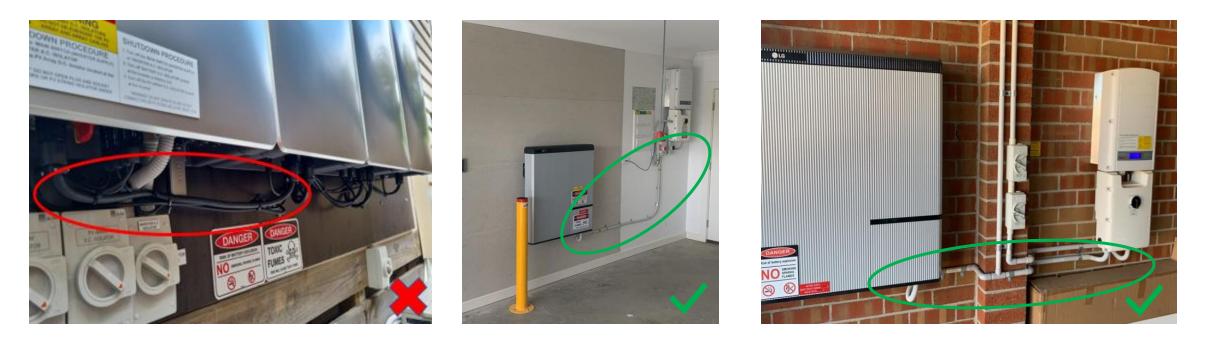
For pre-assembled battery systems above DVC-A (>60Vdc), the battery cables must be mechanically protected all the way from the battery system to the inverter/PCE, regardless of overcurrent protection as per AS/NZS 5139:2019 Clause 5.3.1.4.3.

In most situations this will be achieved by enclosing the cables in at least Medium duty conduit, however some circumstance may require additional protection as per appendix H of AS/NZS 3000:2018.

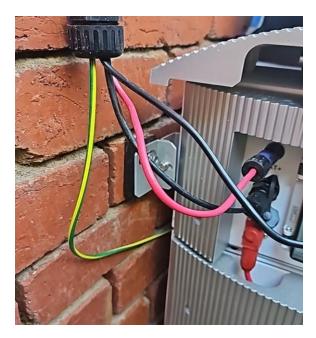
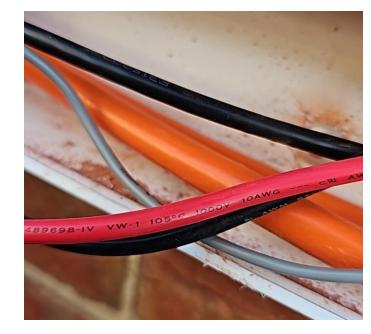
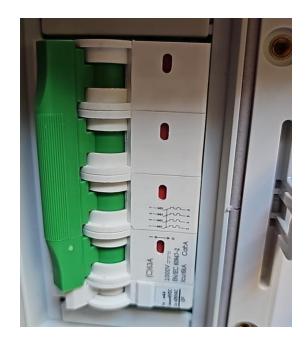
In this example the installer has installed 10AWG (6mm2) dc cabling between the battery system and PCE. The installer is relying on the battery systems integrated 63amp dc circuit breaker as overcurrent protection for the outgoing conductors. As the 63amp circuit breaker is rated higher than the current carrying capacity of the battery cable as per AS/NZS 3008.1 this is considered uncompliant.
